Homeowner Grant Program

1312 U Street, SE

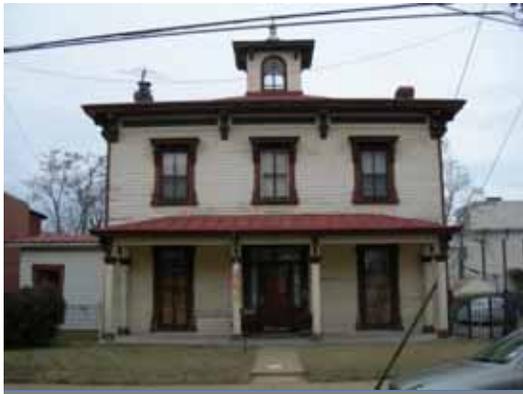
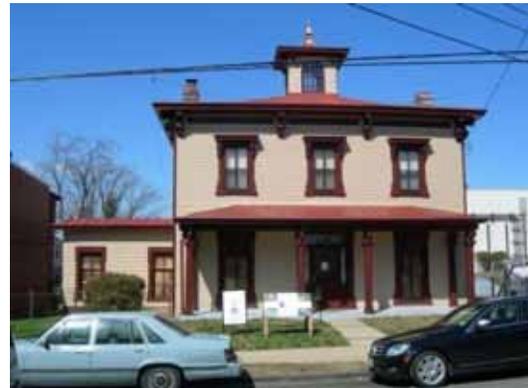
The entire house was in severely deteriorated condition. All wood siding, window and door trims, porch posts, brackets, saw cut ballusters, cornices, the cupola and the roof were scraped clean and free of paint and accumulated debris. All wood components were meticulously restored, saw cut ballusters were replicated to replace rotted and damaged elements, siding was restored and the roof was spot patched. All wood elements were painted, the roofs were sealed with Hydrostop roof sealant system and the concrete porches

were sealed and painted. Outside of the grant the contractor also re-sodded the entire front yard.
